# Support Bulletin

## Autopilot Automated Steering System: *Direction Estimator not initialized* Error Message

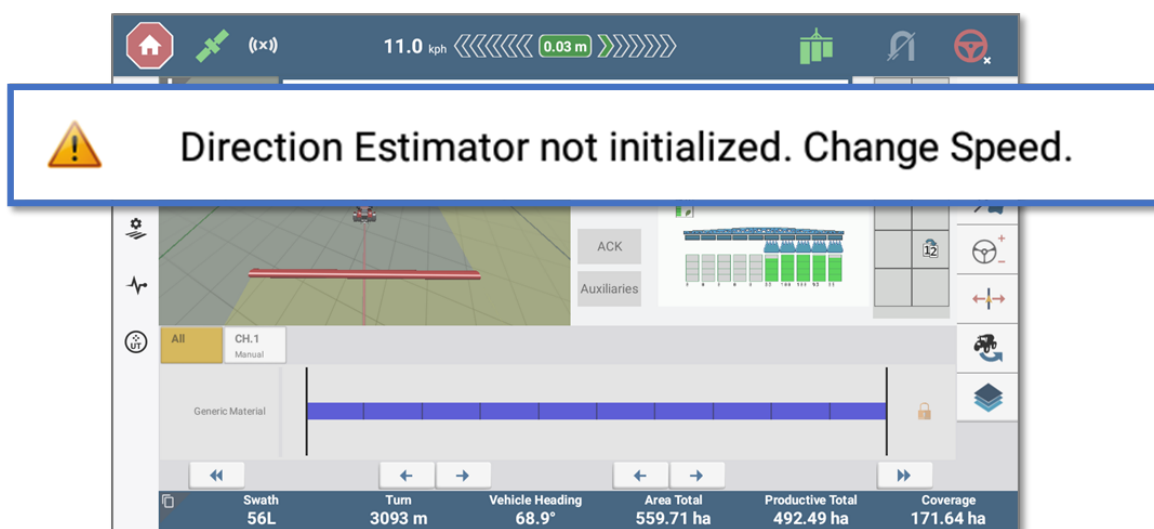
An Autopilot™ issue has been reported of an error message appearing on the Precision-IQ™ Run screen:

This *Direction Estimator not initialized. Change Speed* message seems to affect Autopilot users with the following configurations:

A possible cause of this problem, which is currently being investigated, is the movement of the machine on rough ground. As a result, GPS acceleration becomes unstable.

Contact [Trimble Ag Support](#) for NavController III firmware version 13.75.**91.4** to resolve this issue.
